# Manhole Inspection Summary

Manhole # S21K1\_018MH

Insp Date: **4/25/08 9:16 AM**

**Location** Address: **2647 norland rd**

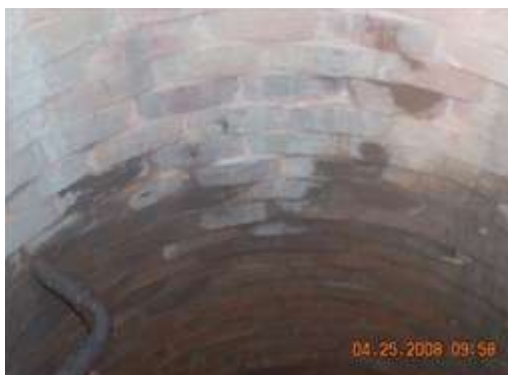
Defect 4

Infiltration: ☐ None ☐ Joint ☐ Cracks ☐ Mortar ☐ Roots ☒ **Wall**

infiltration @ corbel wall

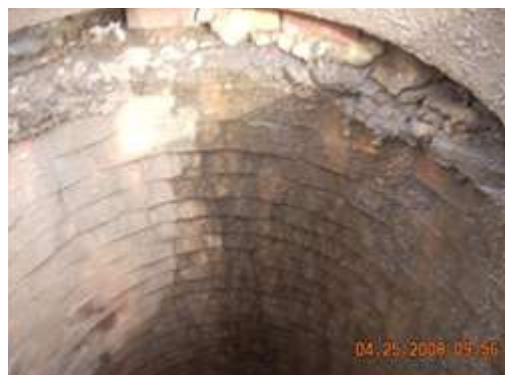
Defect 3

Infiltration: ☐ None ☒ **Joint** ☐ Cracks ☐ Mortar ☐ Roots ☐ Wall

infiltration @ chimney/frame joint

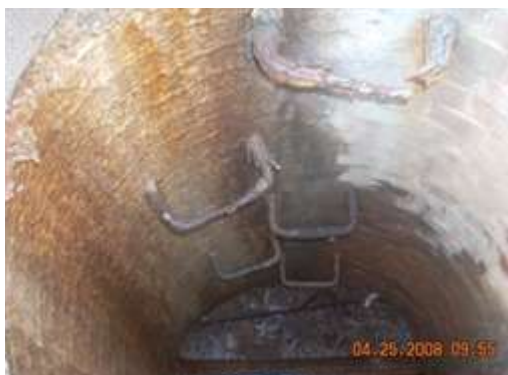
Defect 2

**Steps** Count: **4** Missing: **1** ☒ **Corroded**

corroded steps; top step broken and labeled as missing

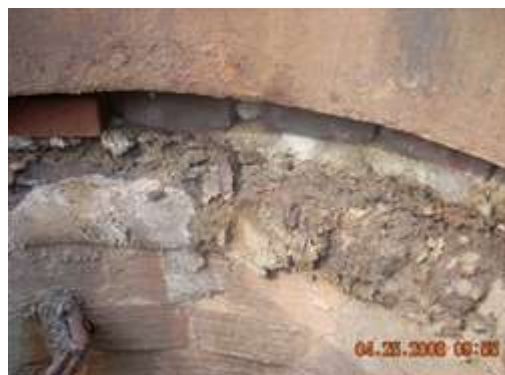
Defect 1

Condition: ☐ Sound ☐ Cracked ☐ Root Intrusion ☐ Loose Brick ☒ **Deteriorated**

deteriorated chimney

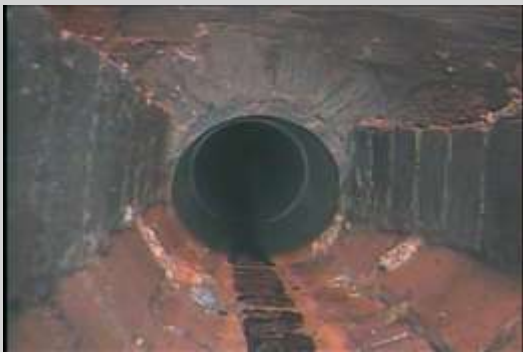
12 O'Clock Outflow

Pipe Height: **7.2** (in.) Rod and Bar (Angled)  
Pipe Material: **Clay** ☐ Pipe Lined  
Invert Depth: **9.20** (ft.) Flow Characteristics: **Slow**  
Deposits: ☒ None ☐ Mud ☐ Sludge ☐ Debris ☐ Grease  
Silt Depth: **0** (in.) Deposits Extent:  
Infiltration: **None** Pipe Seal Cond: **Sound**

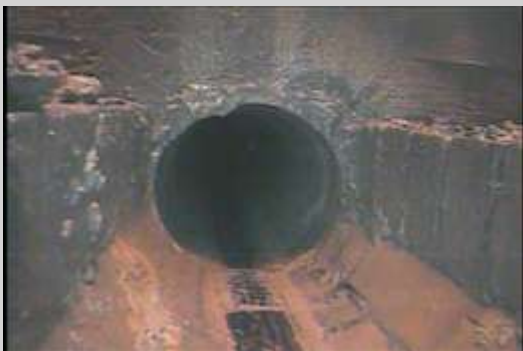
6 O'Clock Inflow

Pipe Height: **7.2** (in.) Rod and Bar (Angled)  
Pipe Material: **Clay** ☐ Pipe Lined  
Invert Depth: **9.03** (ft.) Flow Characteristics: **Slow**  
Deposits: ☒ None ☐ Mud ☐ Sludge ☐ Debris ☐ Grease  
Silt Depth: **0** (in.) Deposits Extent:  
Infiltration: **None** Pipe Seal Cond: **Sound**
